## **Installation/Operation Instructions**

### **Fiber Optic Video/Data Transmission System**

**DT-1V1D1K/1D1K**  
*(Video Transmitter/Data Transceiver)*

**DR-1V1D1K/1D1K**  
*(Video Receiver/Data Transceiver)*

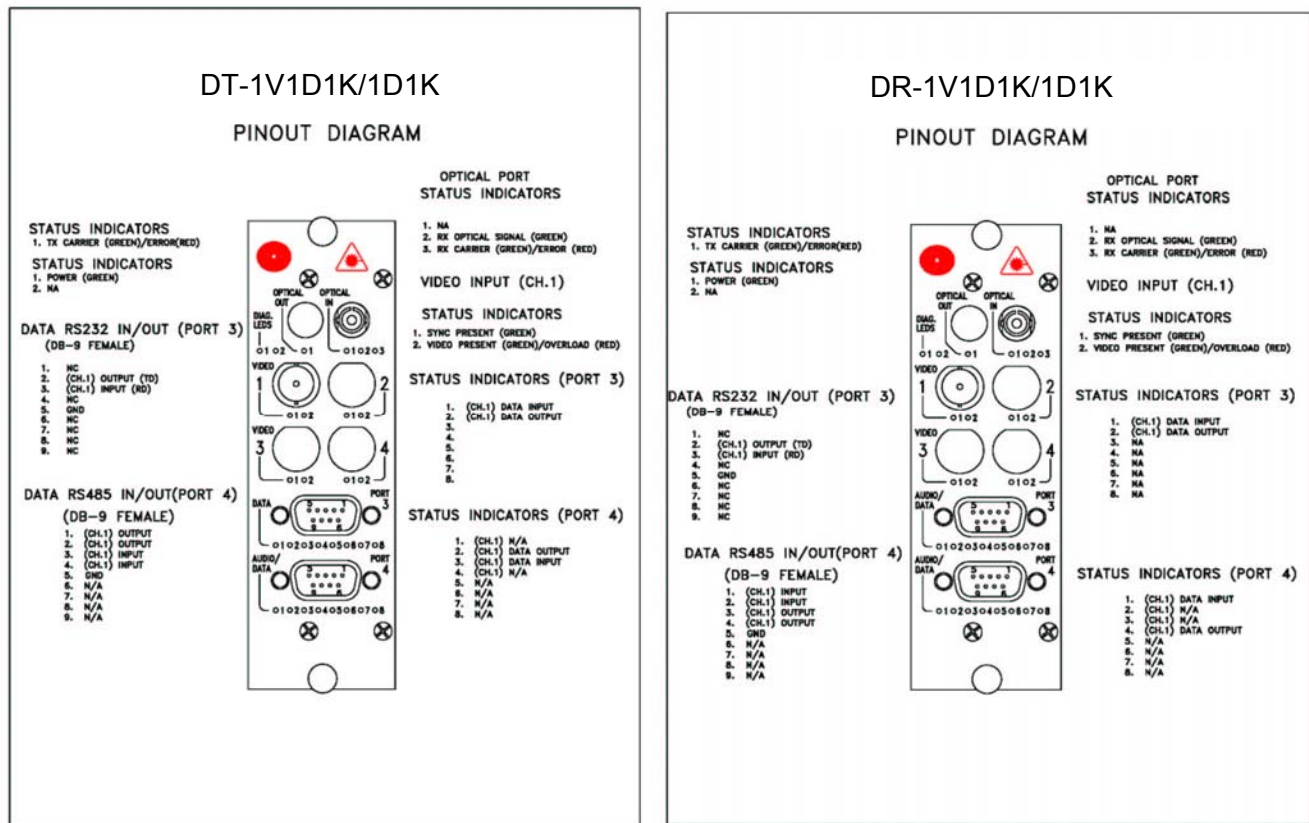
Figure 4.1  
Front Panel Layout/Pinout Diagrams

The digital modules consist of various plug-in personality function cards or SIMs. The top card is the optical card that contains the fiber optic interface. The optical output (Tx) connector is located on the left side of the module while the optical input (Rx) connector is adjacent to it on the right side of the module. The second SIM contains the video Input/Output coaxial interface. The bottom two SIM cards contain the bi-directional data channels (RS-232 & RS-485, respectively)
