## **Fiber Optic Video/Data Transmission System**

### ***Installation Instructions***

**FT/FR-1HD2A-x (ST/FC)**

***(1-Channel SDI Video, 2-Channel Audio Tx/Rx)***

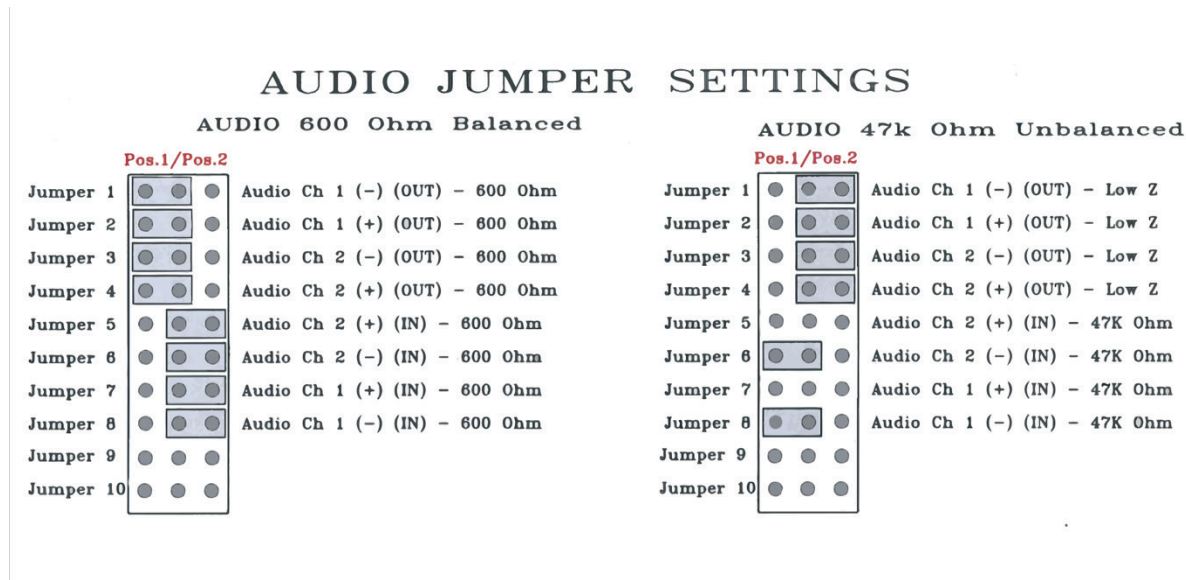
**Figure 4.1**  
**Audio Input / Output jumper setting**

The input/output impedance of each of the audio channels can be changed between 600 Ohm Balanced and 47K Ohm Unbalanced. The default impedance is 600 Ohm. The Jumpers 1-8 are used for Audio Input/Output setting selection (Figure 4.1).

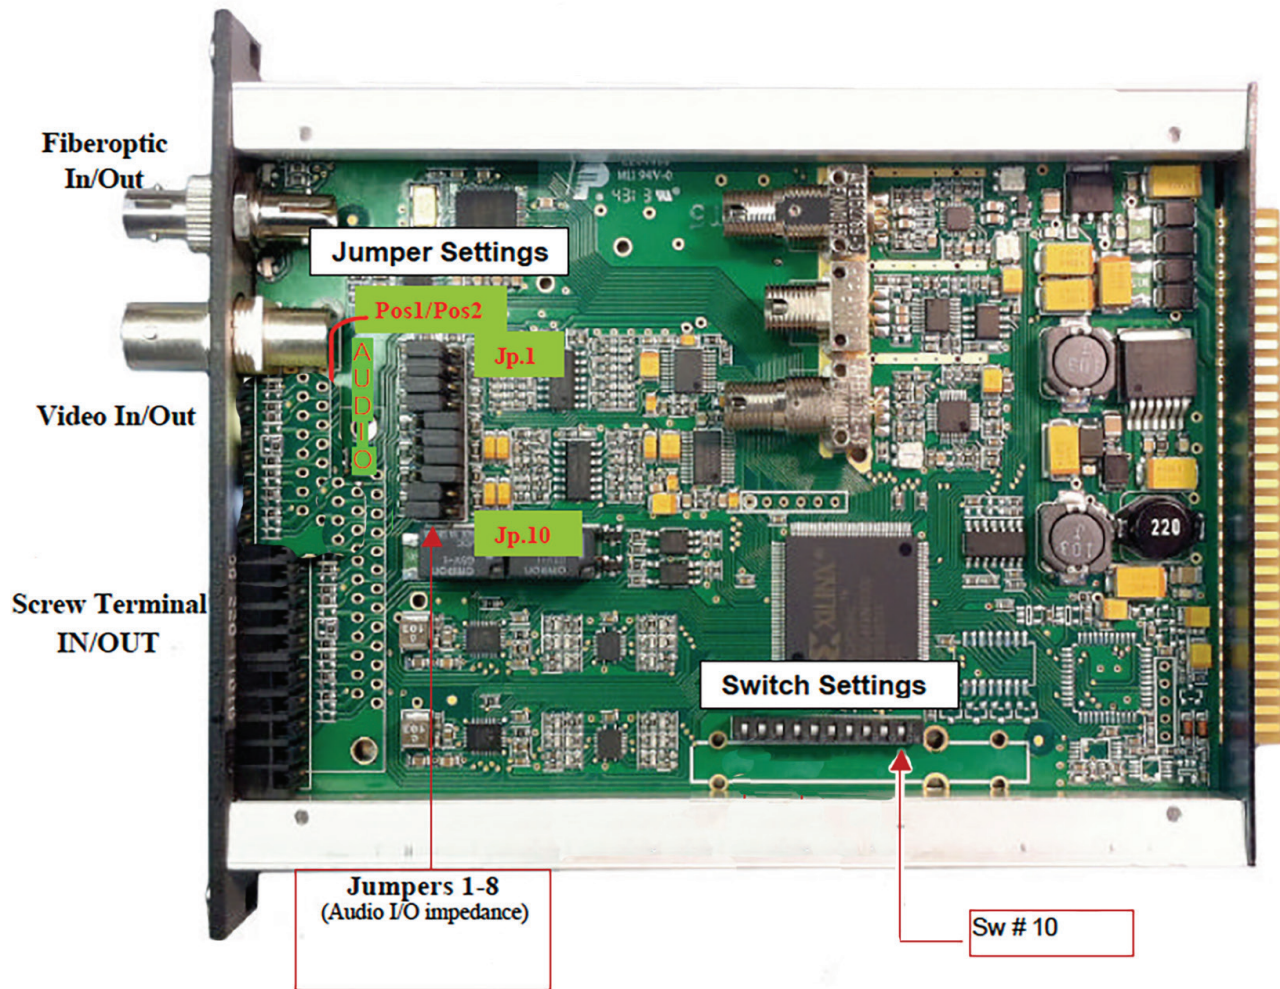
**Figure 4.2**  
**Switch and Jumpers locations diagram**

- Lay the module on its side with the front panel facing to the left.
- Remove the screws in each of the 4 corners of the top cover and carefully lift the cover.
- The Jumpers (1-10) are located behind front panel of the module. (Figure 4.2)
- Using small tweezers or pliers carefully relocate the plugs to properly select the audio format (see Figure 4.1)
- Place the top cover back in place.
- Repeat this process for the other module. The jumper selection needs to be the same for both the FT and FR units.

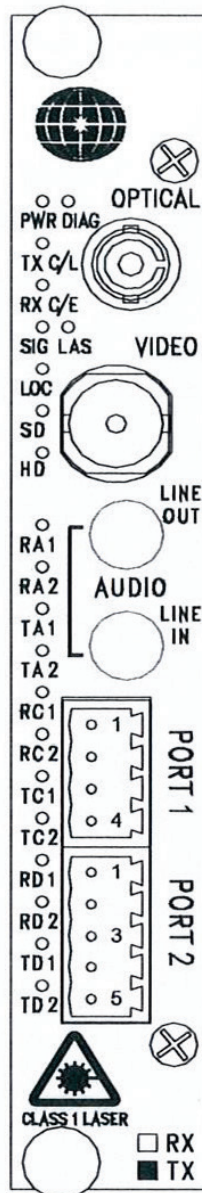
**Figure 4.1**  
**FT-1HD2A-x Front Panel Layout Diagram**

PWR - POWER (GREEN)  
 DIAG - CARD DIAGNOSTIC\*  
 (GREEN-OK, RED-ALARM)  
 TX C/L - TX CARRIER (GREEN)  
 / ERROR (RED)  
 RX C/E - NA

LAS - SDI LASER (GREEN)/ FAIL (RED)  
 SIG - SDI SIGNAL PRESENT (GREEN)  
 LOC - SDI SIGNAL LOCK (GREEN)  
 SD - SDI PRESENT (GREEN)  
 HD - HDSI PRESENT (GREEN)

RA1 - NA  
 RA2 - NA  
 TA1 - (CH.1) AUDIO INPUT (GREEN)  
 TA2 - (CH.2) AUDIO INPUT (GREEN)

## FT-1HG2A-5/ST PINOUT DIAGRAM

OPTICAL PORT (ST, FC)

SDI VIDEO INPUT

PORT 2 AUDIO INPUT

1. (CH.1) AUDIO INPUT+
2. (CH.1) AUDIO INPUT-
3. (CH.2) AUDIO INPUT+
4. (CH.2) AUDIO INPUT-
5. GND

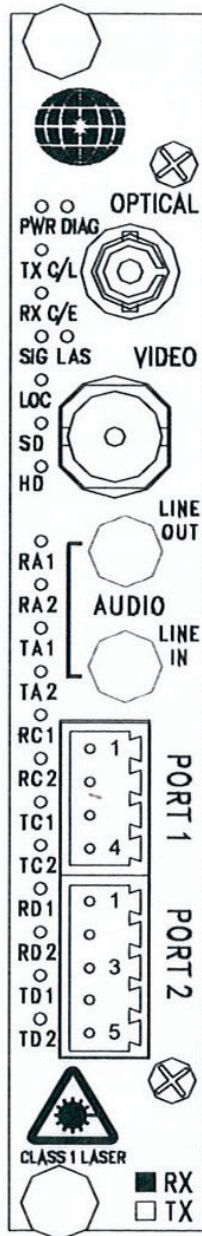
**Figure 4.2**  
**FR-1HD2A-x Front Panel Layout Diagram**

PWR - POWER (GREEN)  
 DIAG - CARD DIAGNOSTIC\*  
 (GREEN-OK, RED-ALARM)  
 TX C/L - NA  
 RX C/E - RX CARRIER (GREEN)  
 / ERROR (RED)  
 LAS - SDI LOCK (GREEN)/ LOSS (RED)  
 SIG - SDI LEVEL 0/-5dBm (GREEN)  
 LOC - SDI LEVEL -5/-10dBm (GREEN)  
 SD - SDI LEVEL -10/-15dBm (GREEN)  
 HD - SDI LEVEL -15/-20dBm (GREEN)  
 RA1 - (CH.1) AUDIO OUTPUT (GREEN)  
 RA2 - (CH.2) AUDIO OUTPUT (GREEN)  
 TA1 - NA  
 TA2 - NA  
 RC1 - NA  
 RC2 - NA  
 TC1 - NA  
 TC2 - NA  
 RD1 - NA  
 RD2 - NA  
 TD1 - NA  
 TD2 - NA

## FR-1HG2A-5/ST PINOUT DIAGRAM

OPTICAL PORT (ST, FC)

SDI VIDEO OUTPUT

PORT 2 AUDIO OUTPUT

1. (CH.1) AUDIO OUTPUT+
2. (CH.1) AUDIO OUTPUT-
3. (CH.2) AUDIO OUTPUT+
4. (CH.2) AUDIO OUTPUT-
5. GND
