## **Installation/Operation Instructions**

### **Fiber Optic Video Transmission System**

##### **ST/SR-2HD-X (ST/FC)**

##### **ST/SR-2HG-X (ST/FC)**

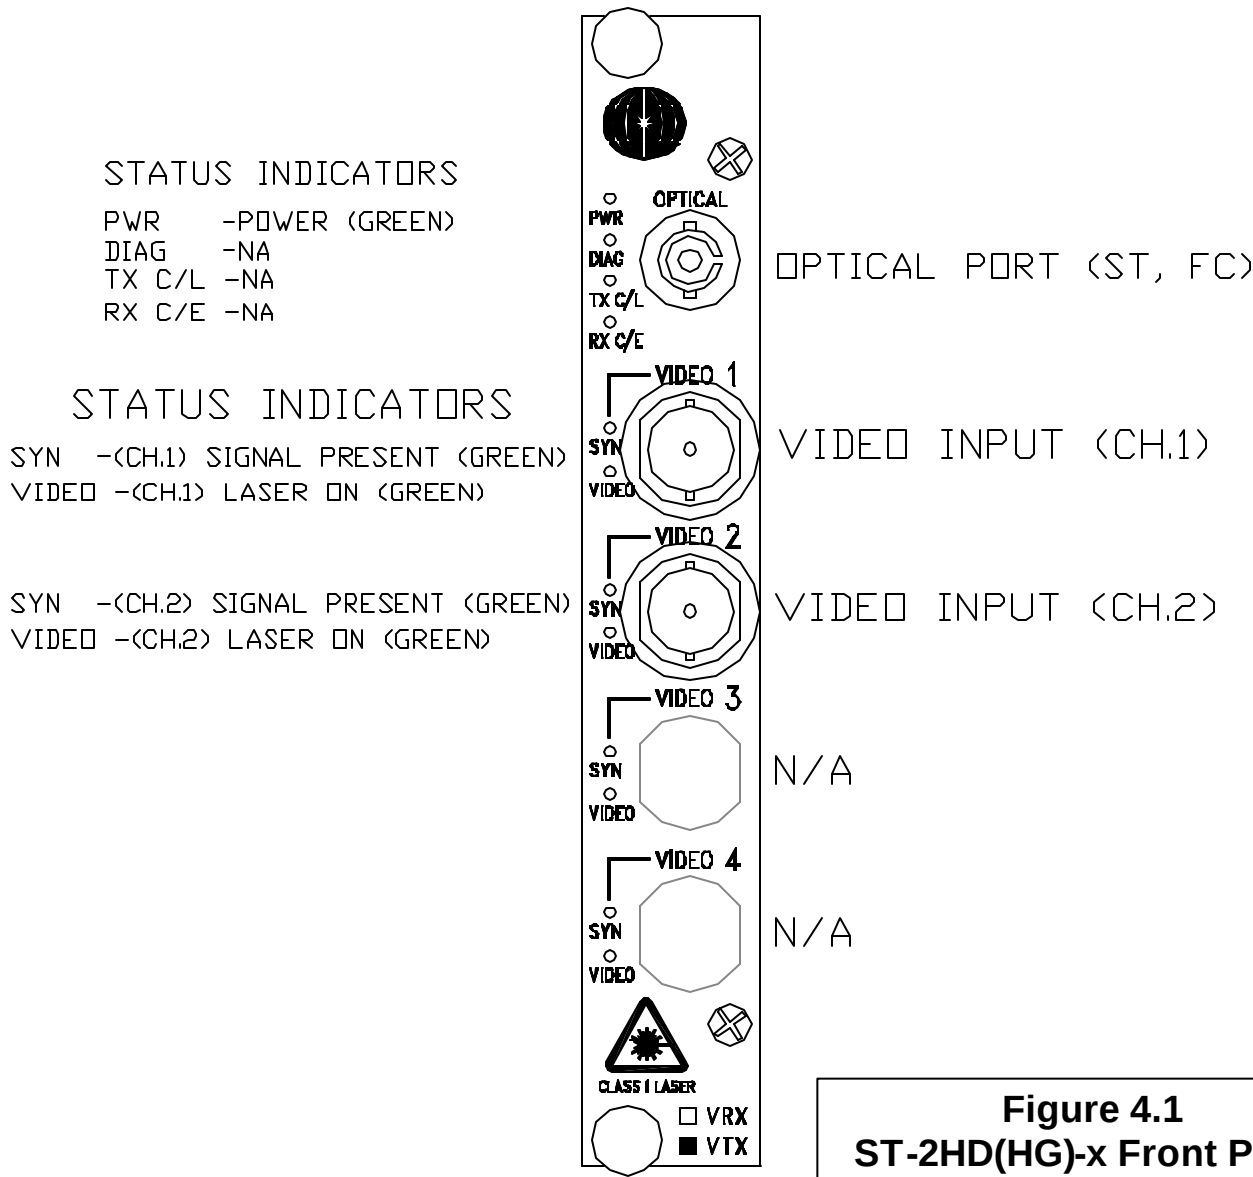
**Figure 4.1**  
**ST-2HD(HG)-x Front Panel**  
**Layout Diagram**

## PINOUT DIAGRAM

Figures 4.1 and 4.2 below show the front panel layout, connector location and pinout assignment for both the ST & SR cards in a 2-ch configuration.

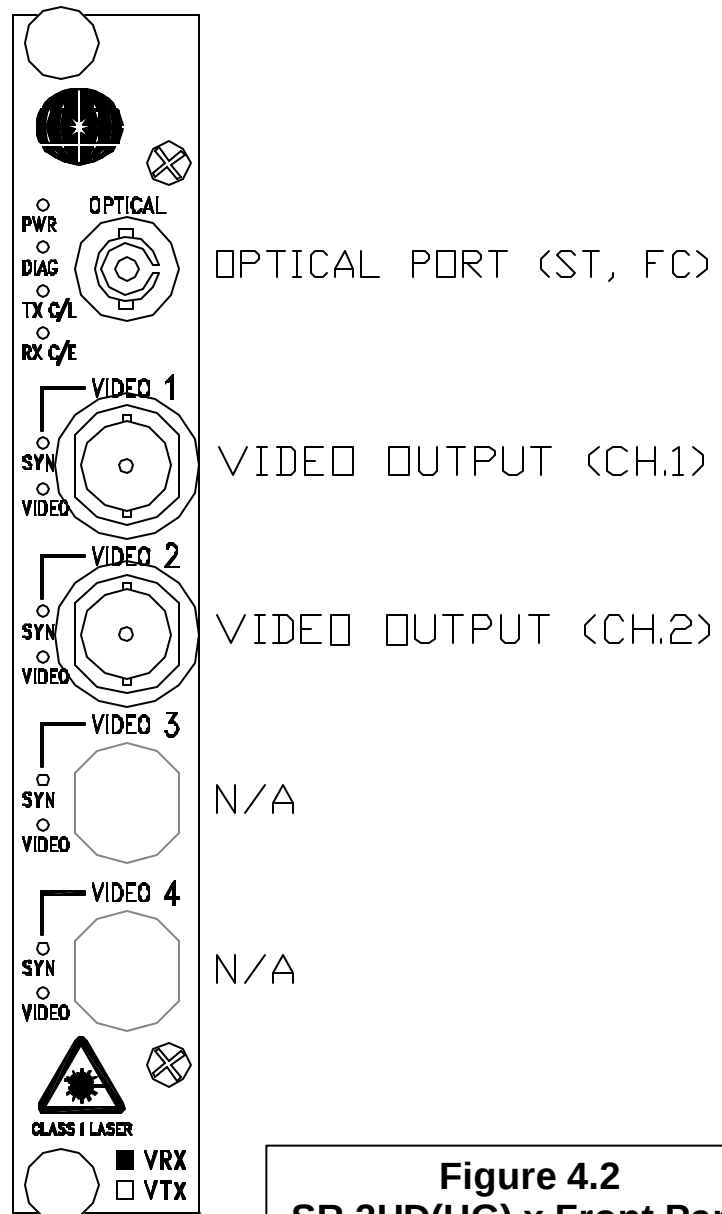
**Figure 4.2**  
**SR-2HD(HG)-x Front Panel**  
**Layout Diagram**

## PINOUT DIAGRAM

### STATUS INDICATORS

PWR -POWER (GREEN)  
DIAG -NA  
TX C/L -NA  
RX C/E -NA

SYN -(CH.1) LEVEL 0/-10dBm (GREEN)  
VIDEO -(CH.1) LEVEL -10/-20dBm (GREEN)

SYN -(CH.2) LEVEL 0/-10dBm (GREEN)  
VIDEO -(CH.2) LEVEL -10/-20dBm (GREEN)
