## ***Installation/Operation Instructions***

### ***Fiber Optic Video Transmission System***

##### ***ST/SR-8HD-x***

##### ***ST/SR-8HG-x***

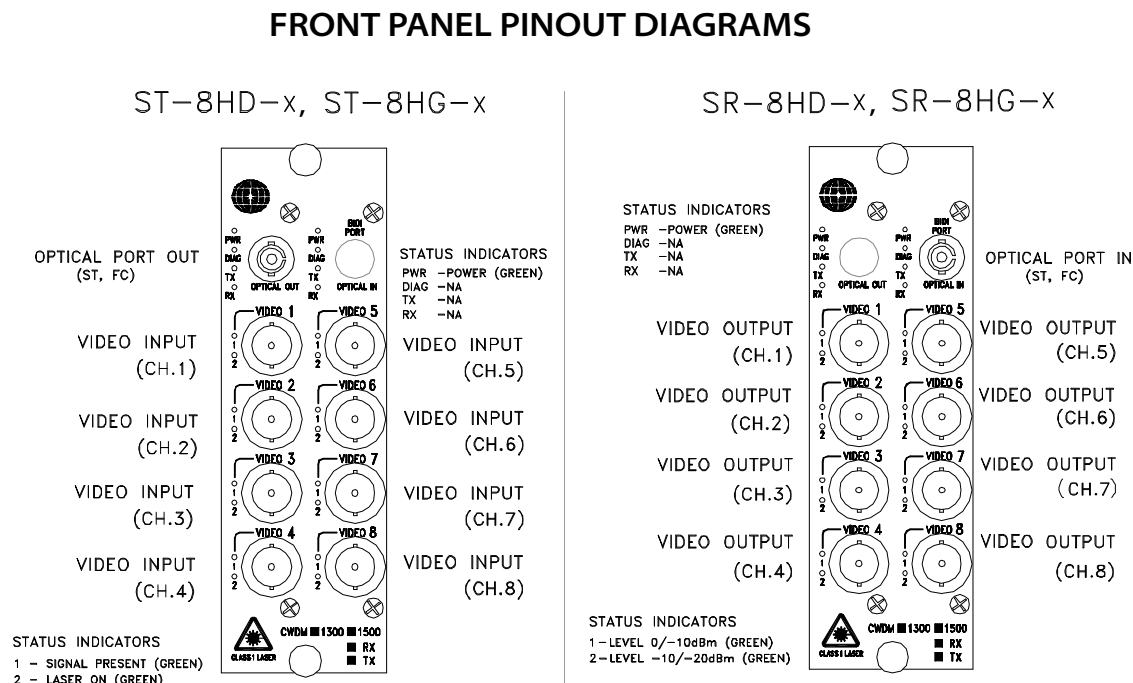
Figure 4.1

Figures 4.1 and 4.2 below show the front panel layout, connector location and pinout assignment for both the ST & SR cards with or without Expansion Port.
