## **Installation/Operation Instructions**

### **Fiber Optic Video Transmission System**

##### **SXA-2HD-CWDM (ST/FC)**

##### **SXB-2HD-CWDM (ST/FC)**

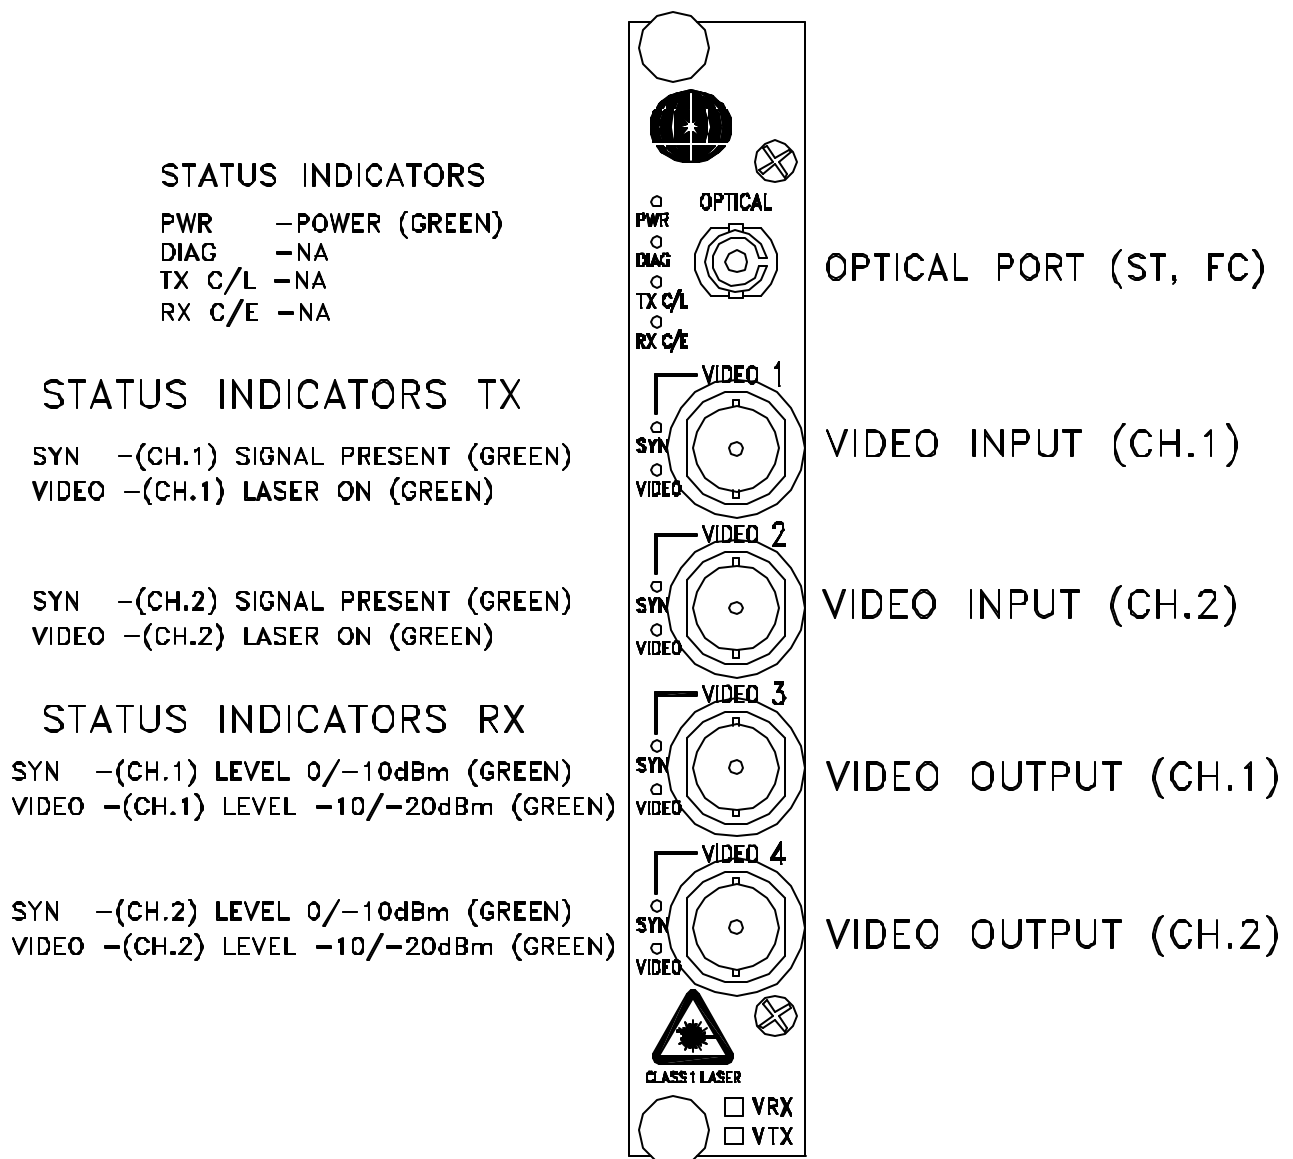
**Figure 4.1**  
**SXA/SXB-2HD(G)-x Front Panel Layout Diagram**

Figures 4.1 below show the front panel layout, connector location and pinout assignment for both the SXA & SXB cards in a 2-ch configuration.

# SXA/SXB-2HD-CWDM

## PINOUT DIAGRAM
